Changes to Sentinel OTP Miscellaneous Module 2, Group 2

IGS 256—Derailment within Summit Tunnel as a result of falling ice

Invensys OHSE Alert—Undetected—Cable Threats

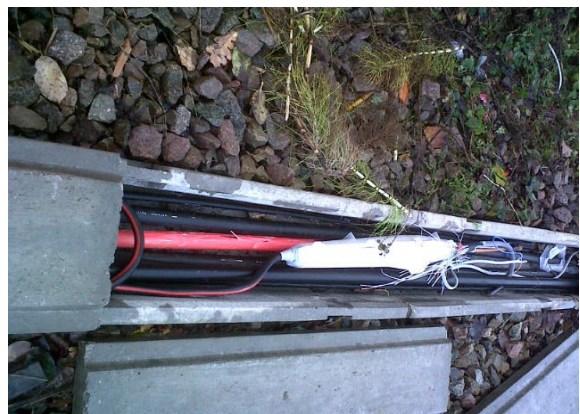
Be aware cable thefts with a difference are taking place which leave an extremely dangerous situation which presents a serious risk to life to anyone inadvertently disturbing this arrangement.

Thieves have stolen lengths of the 95mm 650V 3 core feeder cable and have wound a length domestic twin and earth cable has been wounded onto exposed cores live at 650V and then copper distribution cable cut out and removed.

As a result the train service is not affected. If any unusual circumstances are discovered with the installed cables during works, works must be stopped and the maintainer contacted to check and validate before work re-starts.
