Infrastructure Group Safety Bulletin

HGV DRIVER FATALLY CRUSHED BY RUNAWAY VEHICLE

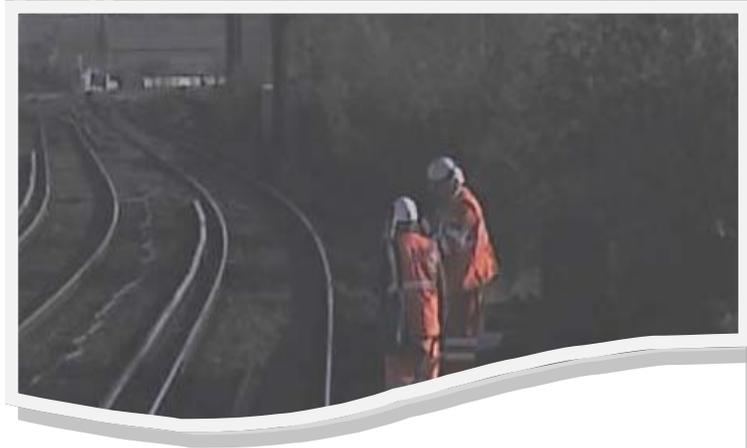
It is believed that the Lookout's bag (possibly the wooden flag poles) was struck from behind by a train, causing the lookout to be pushed to the ground in the cess.

- A safe system of work is maintained at all times
- Lookout(s) remain in appointed positions
- Lookout(s) are not distracted and remain vigilant at all times

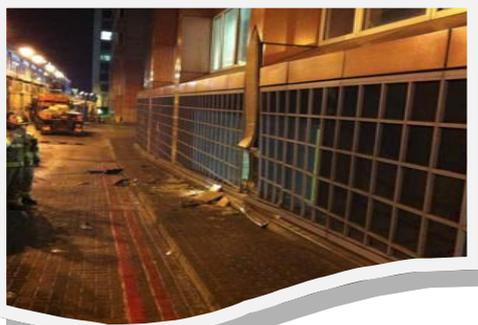
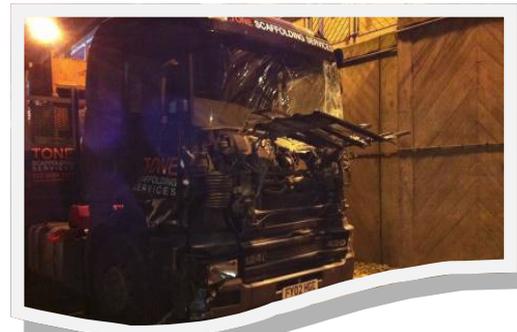
On 15th January a lorry driver from Tone Scaffolding was fatally injured while in the process of collecting scaffolding at Reading. It is currently understood that the lorry driver had arrived on site at approx 23:30hrs and that he had reversed his vehicle in order to auto couple his lorry to the trailer. He then got out of the driving cab to prepare the trailer and as he released the trailer parking brake, the vehicle began to run away. He subsequently ran after it and attempted to gain access to the driving cab. As he did so the vehicle mounted the curb and he was crushed between the wall of an adjacent building and the vehicle. The vehicle continued to run away, going through a barrier and coming to rest when it collided with a large skip placed in the access road. The lorry driver's body was found at the point of impact.

Although the investigation is on-going it is understood that the collection area was situated on a slight incline. When the driver exited the cab he did not engage the tractor unit parking brake.

This meant that when the trailer parking brake was released the vehicle was able to run away.

- Apply the parking brake
- Stop the engine and remove the keys
