## Slips, Trips and Falls

## Tower Scaffold Collapse Risk

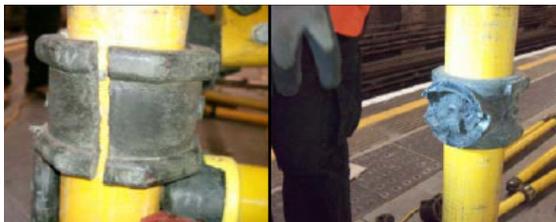
A Glass reinforced Plastic (GRP) tower scaffold partially collapsed whilst two operatives were standing on one of its platforms. Fortunately, only very minor injuries were sustained (grazing to the arm of one of the operatives). Two 'tee joints' supporting the platform failed, leading to the platform dropping approximately 0.5 metres, at a 25 degree angle. Inspection by the manufacturer identified no manufacturing fault. However, a number of issues have been highlighted from the ongoing investigations including:

- Method of erecting was not to manufacturer's guidance.
- Records of component part checks were not available.
- Visible signs of wear and tear including numerous cuts, scuffs, abrasions on the GRP component parts.

It was also highlighted that not all manufacturers identify a recommended life expectancy for this type of equipment.

Duty holders are reminded that they must:

- Ensure that appropriate risk based regimes are in place to inspect work at height equipment, including component parts in compliance with the Work at Height Regulations.
- Erecting of scaffold to be undertaken in accordance with manufacturers guidance.
- Ensure that those staff who are required to undertake inspections are competent to do so.
- Ensure that employees who are required to undertake inspections do so using the manufacturer's guidance.
