Parts Failure on Glass Reinforced Plastic (GRP) Mobile Access Tower

Preventing Rail Head Contamination

Failure to engage overbalance protection (RCI) when using RRV's

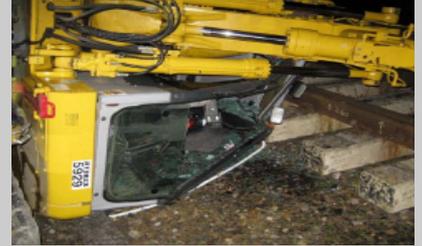
A recent incident took place on a BAM Nuttall site, who were utilising a Road/Rail Vehicle (Komatsu PC138US track excavator), working within an engineers possession.

The RRV was removing sleepers with a sleeper beam, and whilst slewing around the machine became unstable and overturned. The Machine Operator was reported to have sustained cuts to the head and was taken to hospital for further treatment.

The Crane Controller was relieved of duty for interviewing and 'for cause' screening and a difficult recovery process ensued to put the vehicle back upright.

Engineering Supervisors, Crane Controllers, and Machine Controllers are reminded that during ALL lifting operations, the RCI must be switched on at all times. This can be verified by the illuminated blue indication light(s), usually fitted above the operating cab.
