On Track Plan (OTP) Warning Horn

RRV Safety Improvement Programme

Loading Cable Drums on to RRV

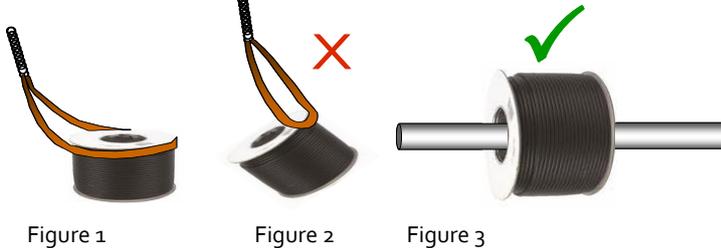
During recent works, a Machine Controller sustained a serious leg fracture when a 2.5T cable drum that was being righted came free from its stop fixing. Although the investigation is still on-going, it appears that the cable drum had been delivered and off-loaded at the RRAP on its base (see Figure 1). In this position, the spindle bar could not be fitted to enable the cable drum to be loaded on to the A frame (mounted on the RRV trailer).

A strop (attached to the RRV lifting arm) was placed around the cable drum (see Figure 1) and the cable drum was lifted/tilted to a position (see Figure 2) to enable the spindle bar to be fitted. During this operation it appears that the cable drum came loose from its strop and the non-pivoted end dropped to the ground trapping the Machine Controller's leg. Initial findings indicate that the laying down of the cable drum on its base has been a factor in this accident and therefore immediate actions required are as follows:

- All Cable Drums should be stored vertically and not placed on their side.
- The laying down of cable drum (for loading on to trailers/A frames) on to their diameters (See Figure 3) is documented in the safe system of work and adhered to.
- Under no circumstances should an attempt be made to 'right' a cable drum using strops (as depicted in Figure 2).
- For all lifting operations ensure that methodology has been approved and documented and a lifting zone is clearly identified and all staff including the machine operator and supervisor is clear before commencing the lifting operation.
