# HSQE Briefing

## May 2017

## Location case doors:

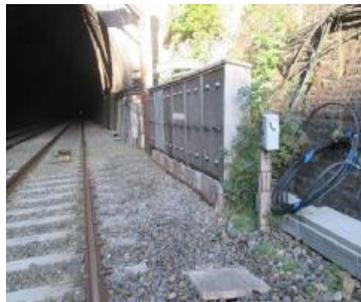
Chipping Sodbury Tunnel Locs

**Overview:** On 20th February the drivers of two trains reported striking metal objects within the 4ft of the Up Badminton line at Chipping Sodbury Tunnel. The train strikes were identified as redundant location case metal doors at the mouth of Chipping Sodbury Tunnel, substantial damage and some loss of power was sustained to both trains.

**Lesson Learned:** Although the event is currently under investigation checks on tools, materials and equipment should be undertaken during and on completion of works. Location case doors existing and redundant should be securely fixed on hinges closed and locked.

**Remember:** Tools and equipment must not be placed any closer than 2 metres (6 feet 6 inches) from a line on which a train could pass as per GE/RT8000/HB1 (7.1).

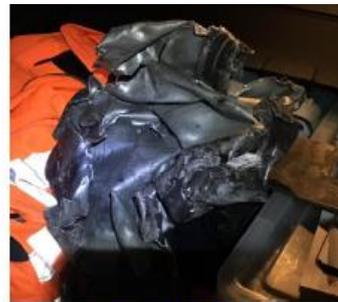
Remains of a door
